Appendix F1 – Assessment of Controls (Watershed Restoration Assessment)

**WHEEL CREEK
WATER CHEMISTRY MONITORING
YEAR 9 REPORT**

Final, December 23, 2019

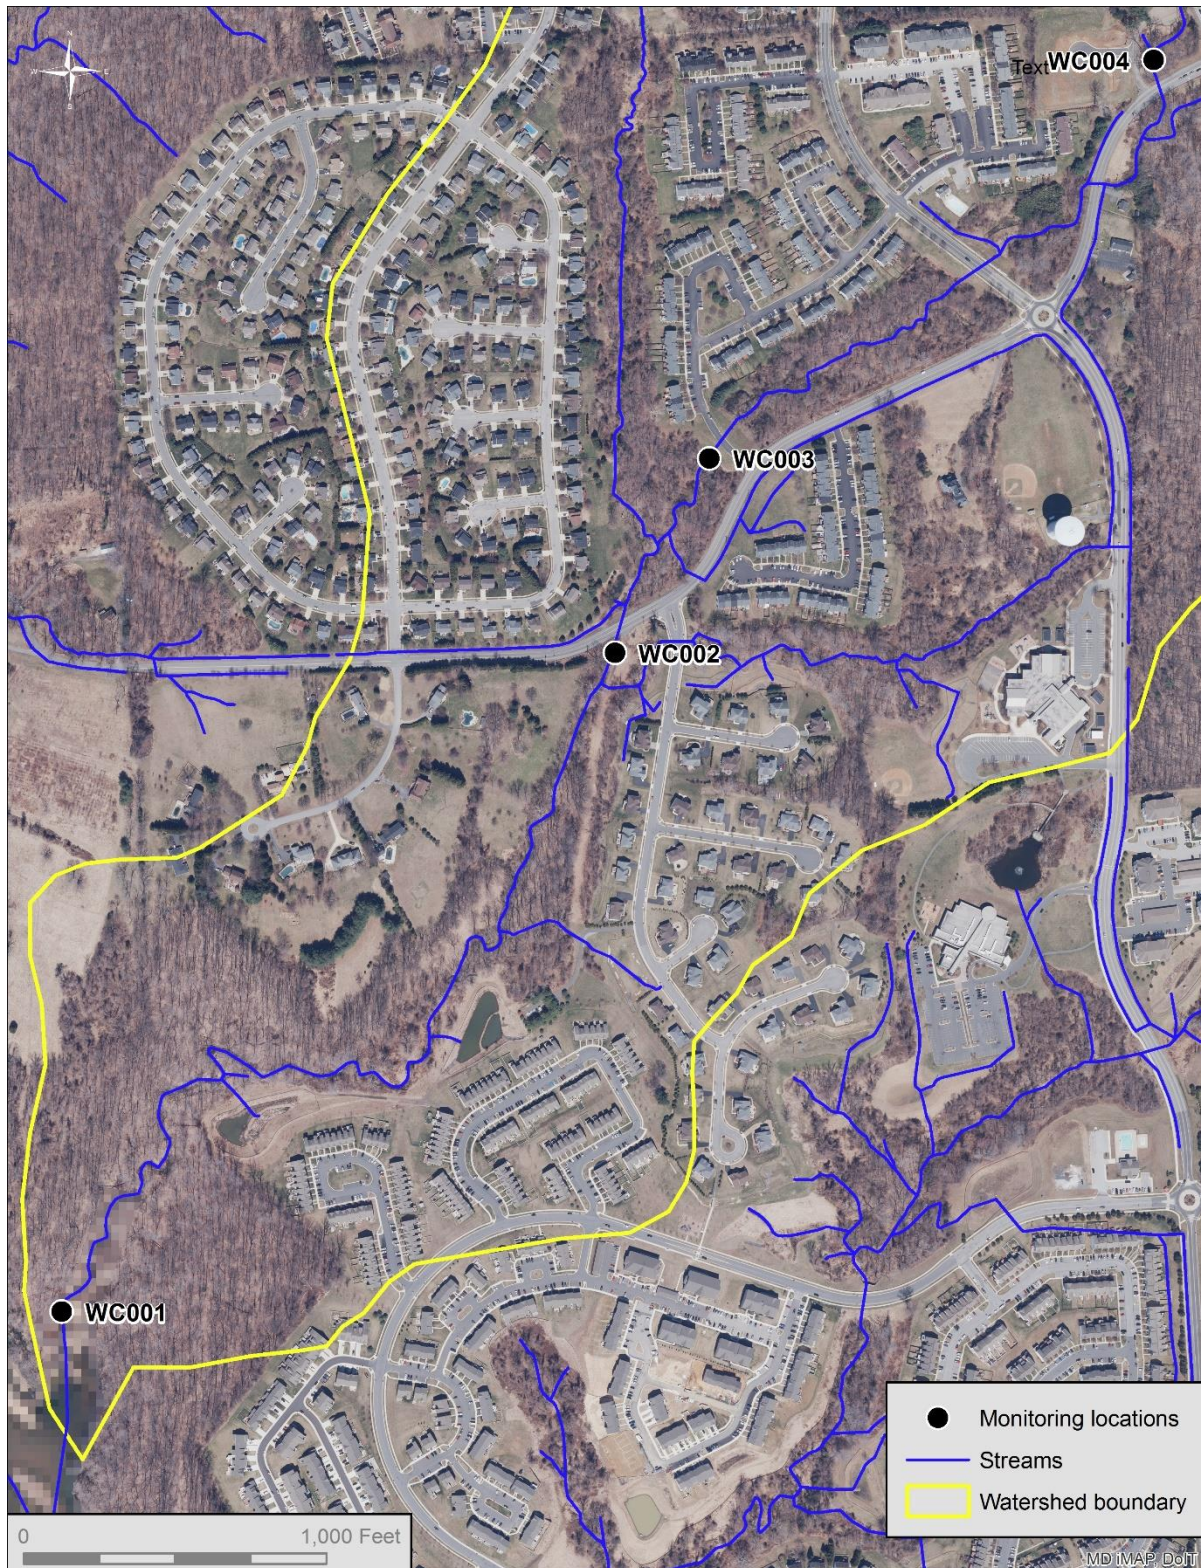
Figure 2-1. Wheel Creek Watershed long-term water chemistry monitoring stations

Three long-term automated water chemistry sampling and flow logging stations were established at Stations WC002, WC003, and WC004 (Figure 2-1). Station WC004 is located on the middle branch, immediately downstream of the stormwater retrofit at Festival Shopping Center (Point C). Stations WC003 and WC004 bracket completed stormwater retrofits at Pond D and Pond E along the middle branch. Station WC002 is located on the mainstem and water chemistry data collected there will provide an overall assessment of the benefits of retrofit and restoration projects in upstream tributaries (Figure 2-2). Baseflow monitoring took place at three stations along the Wheel Creek main stem and tributaries (WC002, WC003, and WC004).
